# Rope access team repairs coronal capping of smokestack

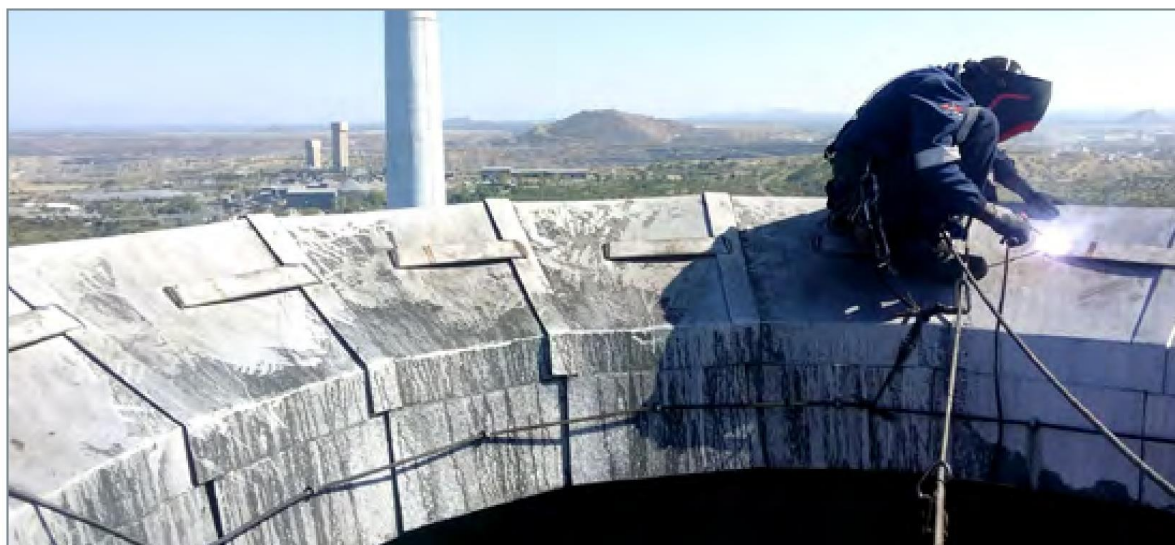
AFTER prolonged exposure to regular lightning strikes had caused structural damage to the tip of a 106m-high smokestack located at a copper mine in Phalaborwa, rope access specialist Skyriders was contracted to complete the repair work.

Skyriders marketing manager Mike Zinn explains that a team of five rope access specialists successfully repaired the steel lightning protection capping on the top of the structure, which protects the top of the smoke stack, within eight days

“With issues like lightning strikes, high winds, thermal variations and the velocity of the exhaust gases from the stack the capping can become misaligned. Our task was to realign the various stainless steel components, before welding it to a belt to secure it safely. The biggest challenge was accurately welding the steel at such height, however, this obstacle was easily overcome as the Skyriders team boasts in-depth skills and experience in this regard,” he states.
